STRUCTURAL BUILDING COMPONENTS MAGAZINE

January/February 2002

What Causes Poor Construction? The Answer Is in the Details by W. T. "Dusty" Yaxley, P.E.

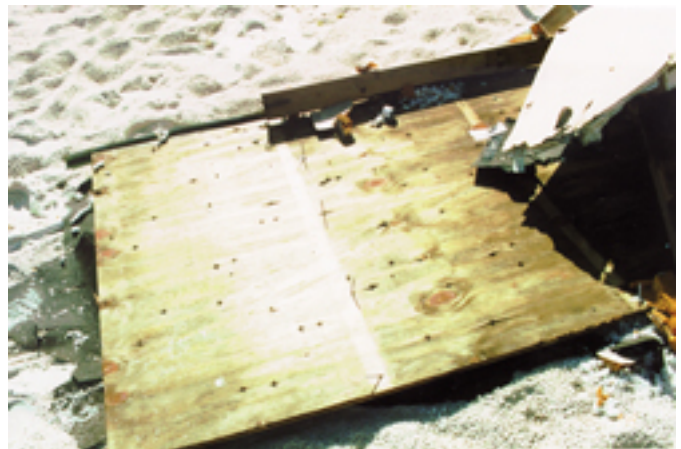
Many examples of poorly-connected materials were verified after Hurricane Andrew. For example, roof sheathing was often found with as few as four nails in a 4x8 sheet of plywood. Concrete tile roofs contributed dead load to hold the sheathing in place until a strong wind blew off the roof tiles and the sheathing. The condition shown in Figure 1 was from another hurricane in the Northern Gulf of Mexico. The photograph proves that the roof sheathing was poorly nailed.

Figure 1. I found this nailing condition in many sheathing boards at the site of the collapse. Note that of the four nails visible, three completely missed the truss below. This was not an isolated example for this site; many roof sheathing boards looked similar. This building was only four years old.

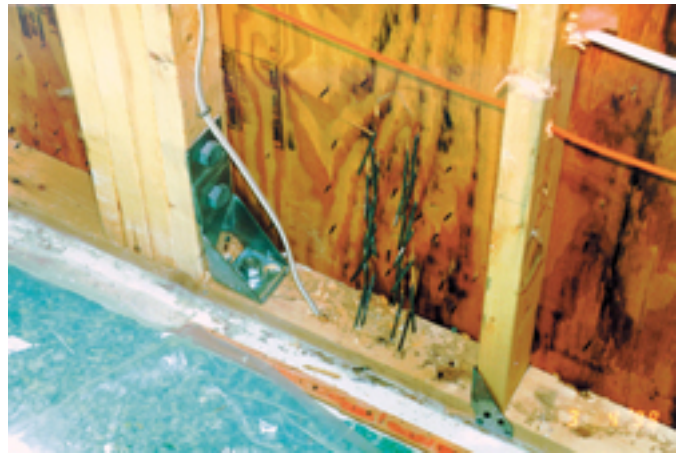
Providing a complete load path is another item frequently ignored. For example, if a heavy framing anchor bolts into vertical studs, those studs must be fastened together to act as one piece without splitting (see Figure 6). Figure 2 shows four studs that are grouped together beside a window. This group of studs have minimal nails—about five nails per stud—to transfer the shear. This anchor was listed in the catalog as transferring 4,000 pounds.

First of all, the 4,000-pound capacity is based on Group II wood, and this building had Group IV wood. This anchor was also depending on the shear transfer from all the studs as a unit. Not enough nails were provided to have the studs act as a unit. Furthermore, this anchor specifically limits the horizontal holes to be less than 1/16 inch larger than the bolts. The holes were 1/8 inch oversized for ease of installing the horizontal bolts. Shrinkage of the wood further enlarged the hole.

The catalog specifically states that the “anchors should be retightened after shrinkage.” No attempt was made to tighten the bolts initially, and they surely weren't tightened later after shrinkage. With the violations to the manufacturer's requirements, this anchor was probably useful for less than half of the load listed in the catalog.

Figure 2. This connection has several problems. The four studs were not nailed together to act as a unit, and the horizontal bolts were loose due to oversized holes.

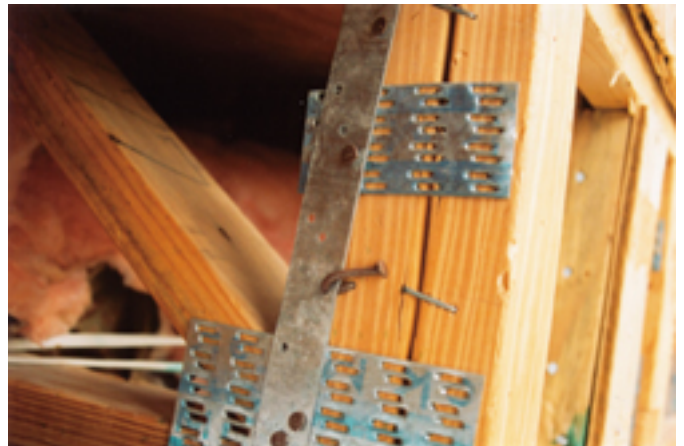
Figure 3. These 4x2 floor trusses were not fastened properly. The vertical anchor from the tie beam was misplaced, and only a few nails hit the wood. The strap was misplaced by three inches and was bent down onto the tie beam and up at the truss.

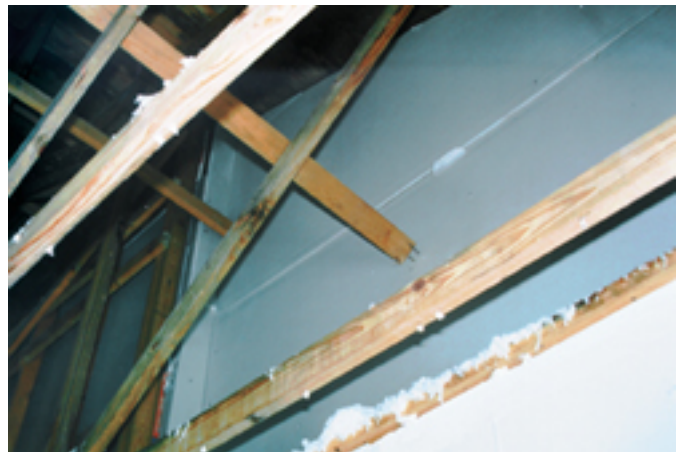
Wood truss designers design wood trusses as individual components and clearly state on their drawings that the engineer-of-record must provide overall system bracing. For example, the lateral bracing is specified on the truss drawings, but must be adequately diagonally-braced to provide stability for the wood truss system. Improper attachment of the lateral bracing system is not unusual. Figure 4 shows a lateral bracing system that was toe-nailed to the drywall firestop, a condition was prevalent throughout that building.

Figure 4. This photo illustrates a typical condition for this building. The lateral braces for the truss system was nailed into the drywall fire break. The fire wall is useless because of the lack of framing to secure the drywall. This building was only four years old.
