STRUCTURAL BUILDING COMPONENTS MAGAZINE

November 2004

Weathering the Storm Reflections on the 2004 Hurricane Season by Libby Walters

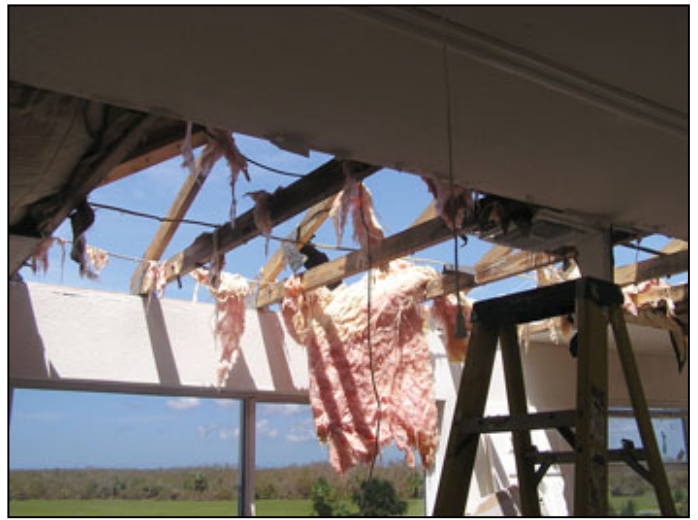
This home was near completion in the Pine Island/Port Charlotte area and the homeowners were days away from moving in. The roof trusses held their ground.

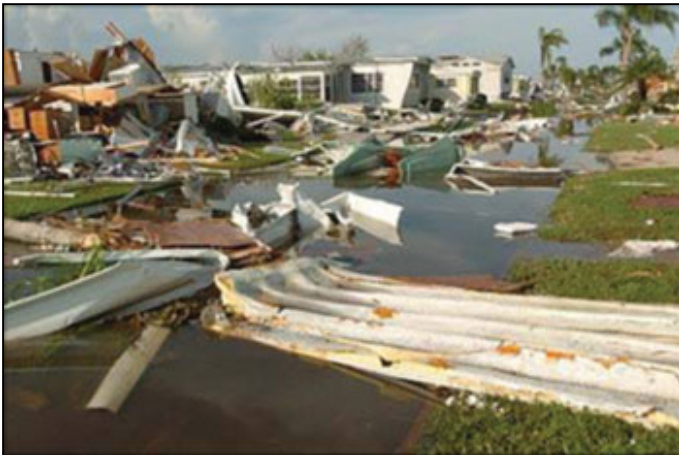
A mobile home park in Punta Gorda, the location where Charley's eye blew through, suffered almost complete devastation.

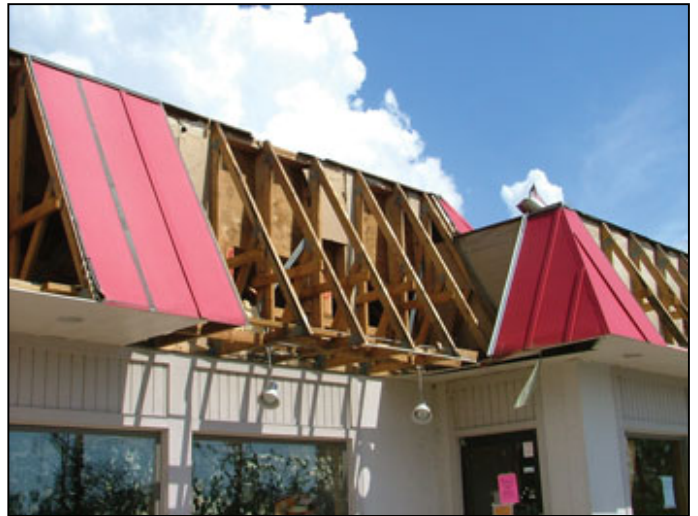
At an Arby's restaurant in Port Charlotte, the structure's truss damage was minimal. Notice that the façade bracing was good.

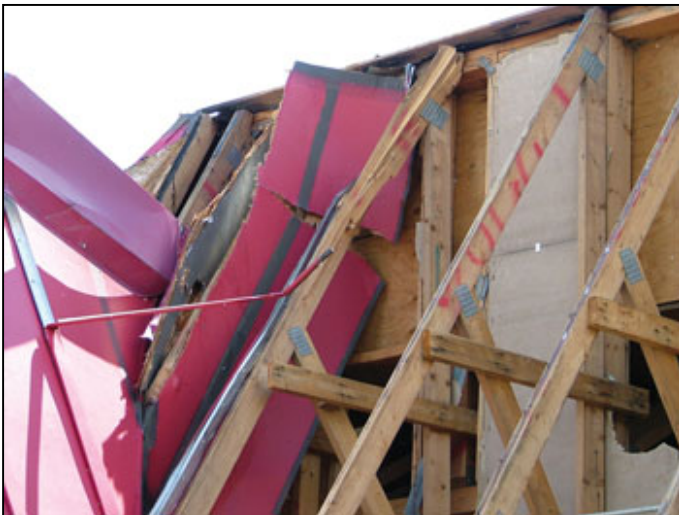
At an Arby's restaurant in Port Charlotte, the sign fell off and hit the roof, breaking one truss member. These façade trusses performed well during the storm due to connections and bracing.

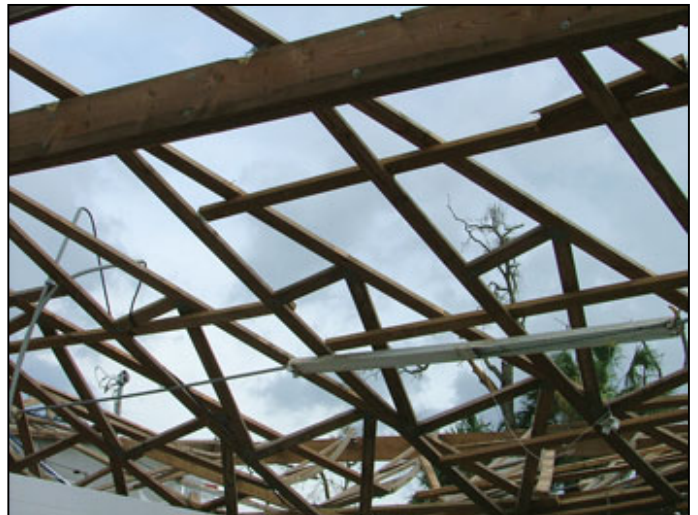
Post frame building with no sheathing; purlins blew off and connected properly and no permanent bracing.

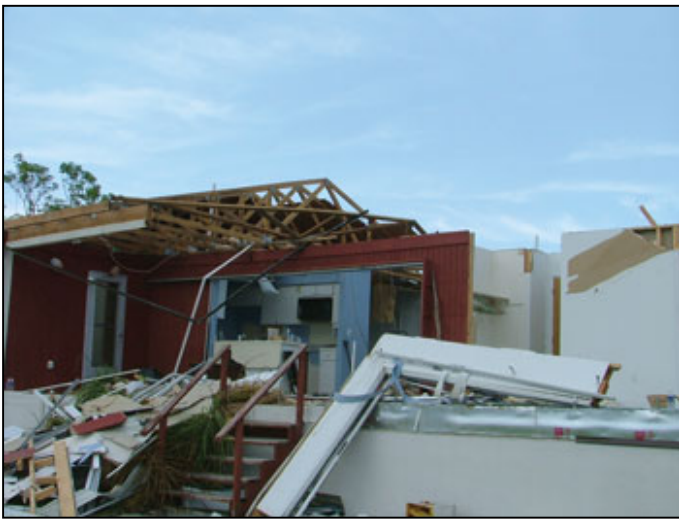
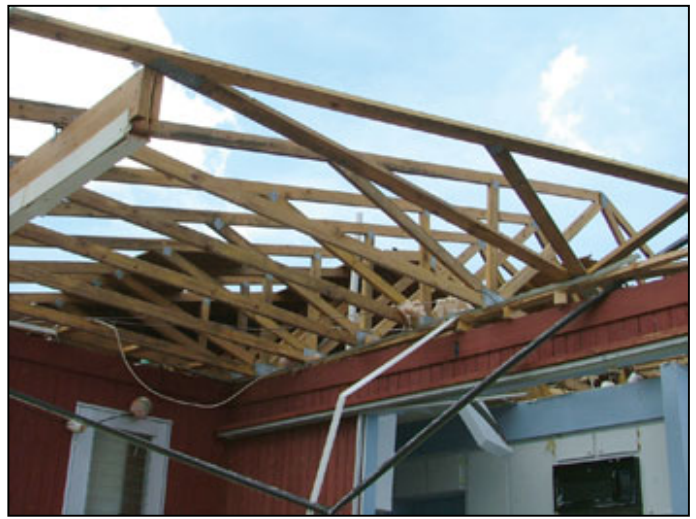
(1 of 2) This home was built in the 1960s and is a total loss.

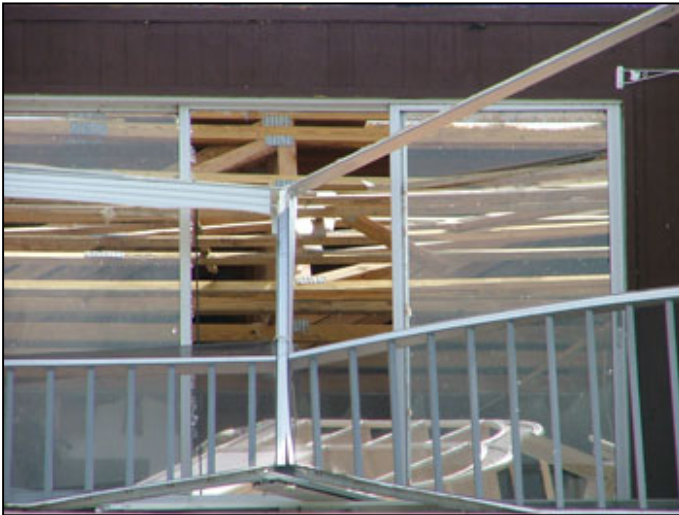
This condo was built in the 60s or 70s, next to Charlotte Harbor. There was no evidence of permanent web member bracing in the roof system and obviously, the plywood roof sheathing was not nailed in place to resist the uplift forces.

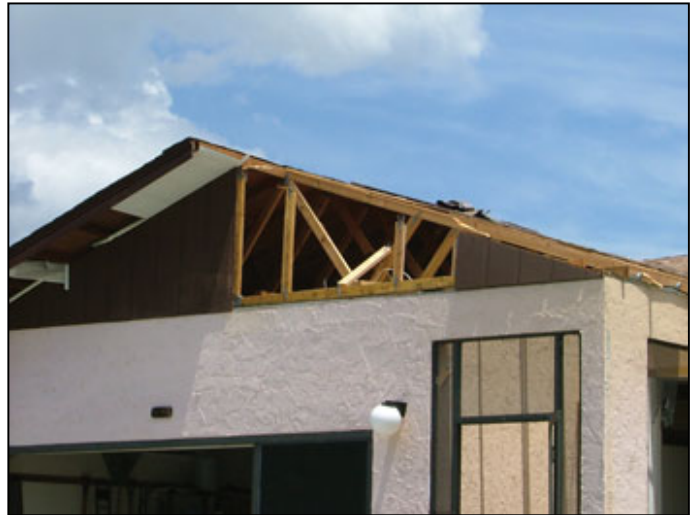
This home was built in 1979 and suffered substantial roof damage as wind blew out all the gables and the roll-up shutters on the lanai. However, the connectors between the trusses and walls performed quite well.

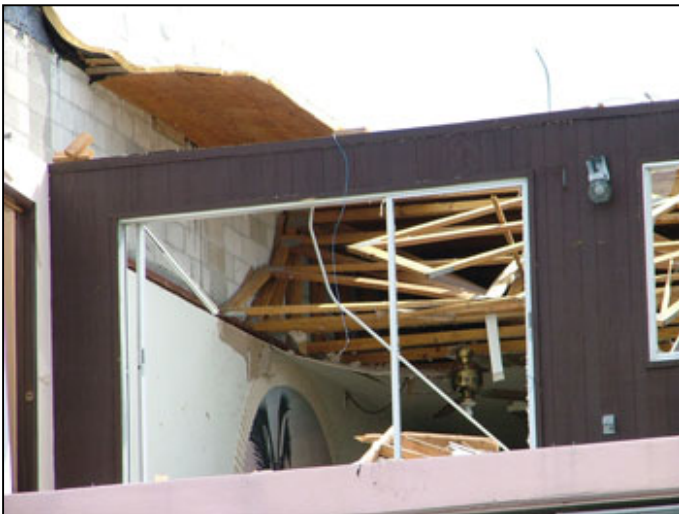
This condominium was built between 1960 and 1970. There is no evidence that the trusses were anchored to anything, and no connections or bracing.

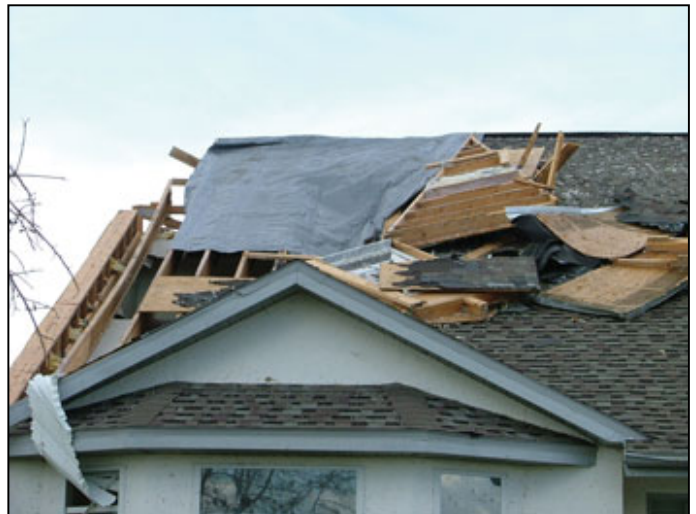
This house shows that both roof trusses and I-joists are susceptible to damage in a hurricane.

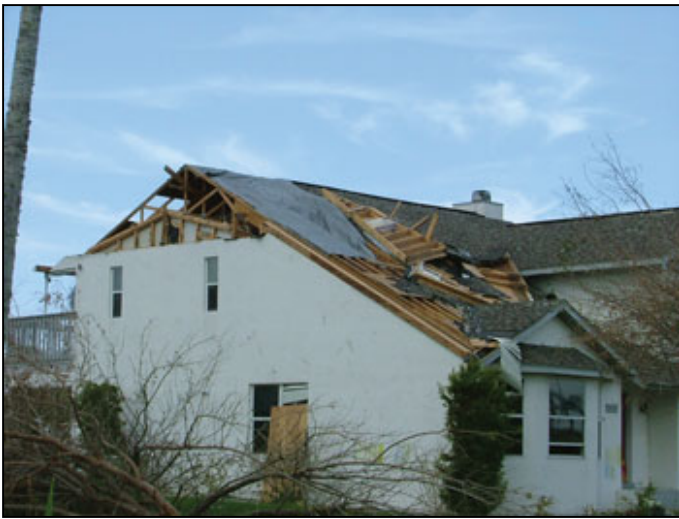
This home built in 1984 sustained considerable roof damage. Again, the truss connections to the wall framing performed well.

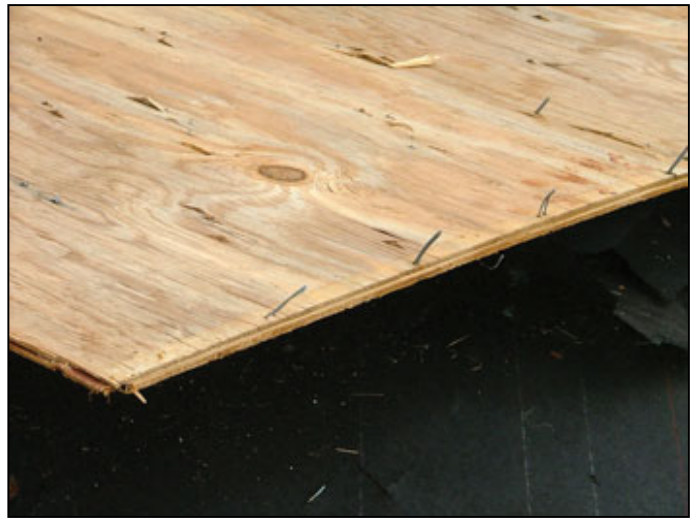
Sheathing fastened with nails and staples.

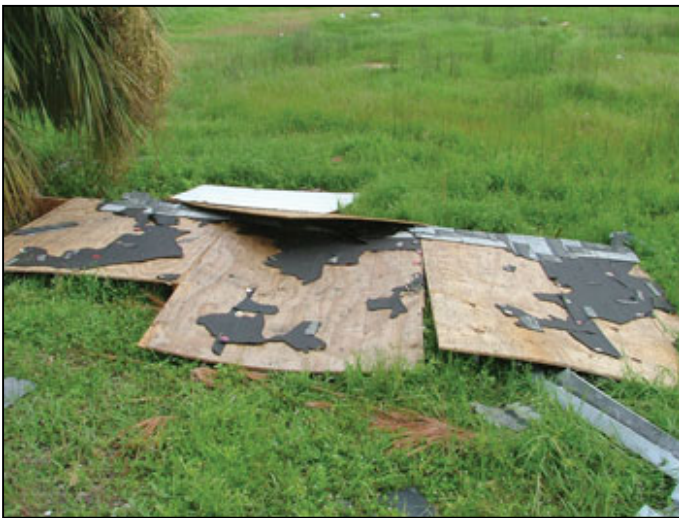
Sheathing ripped off roof.

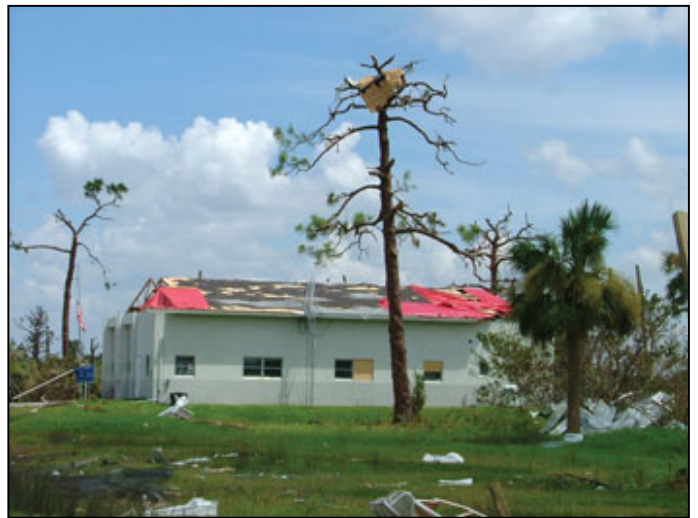
Plywood in tree and torn from the roof.
