# Improving Fire Safety by Understanding the Fire Performance of Engineered Floor Systems and Providing the Fire Service with Information for Tactical Decision Making

March 2012

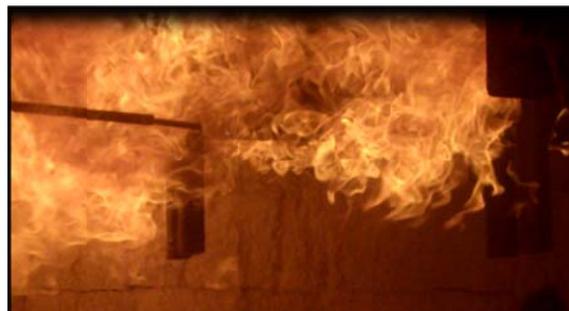
In addition, the availability of video of the burning process for the beams provided insight into the failure path. For the engineered wood I-joists, the failure sequence involves the burnout of the thin web, thereby creating a sudden drop in stiffness as the lower chord, though mostly un-burnt is no longer available for loading sharing.

**Figure 10. Image from video of flaming of web for I-joist fire test**

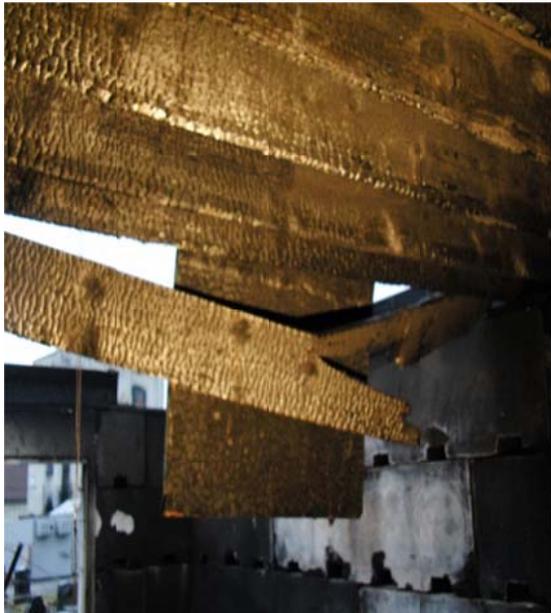
- When possible the floor should be inspected from below prior to operating on top of it. Signs of collapse vary by floor system; Dimensional lumber should be inspected for joist rupture or complete burn through, Engineered I-joists should be inspected for web burn through and separation from subflooring, Parallel Chord Trusses should be inspected for connection failure, and Metal C-joists should be inspected for deformation and subfloor connection failure.

**Figure 46. Dimensional Lumber Joist Fracture**

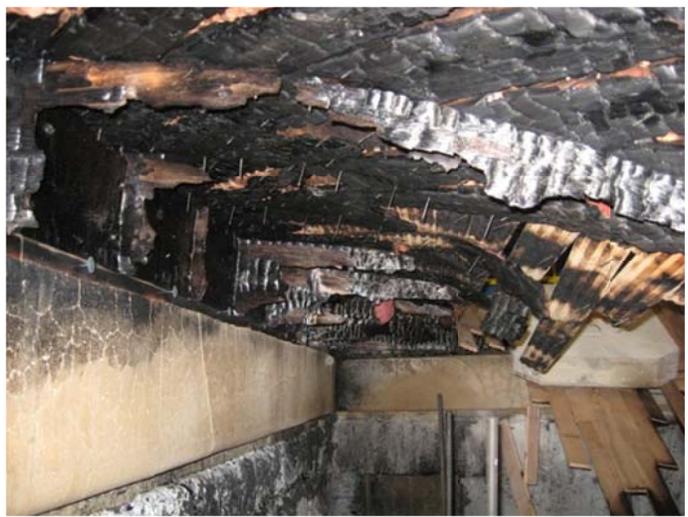
**Figure 47. Dimensional Lumber Complete Joist Burn Through**

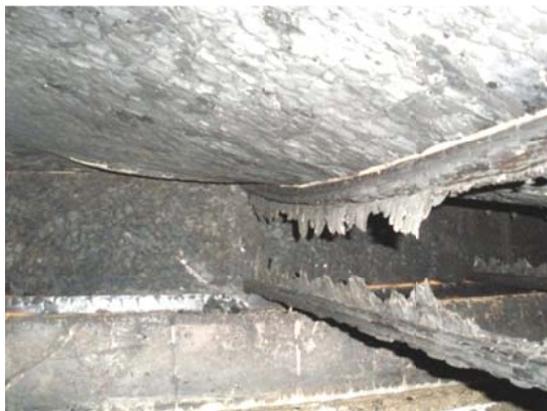
**Figure 48. Engineered I-joist Web Burn Through**

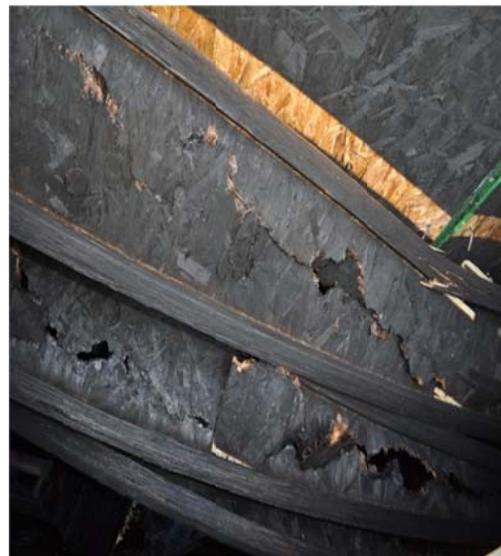
**Figure 49. Engineered I-joist Web Failure and Sheathing Separation**

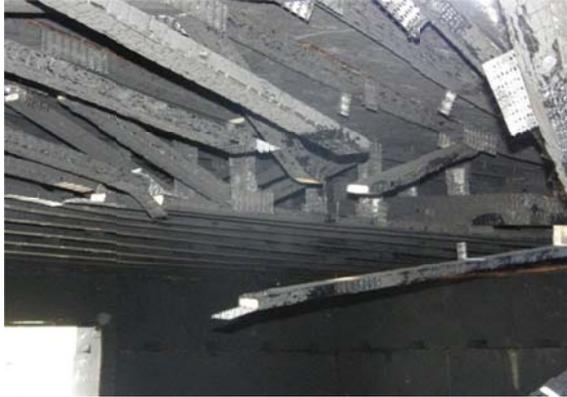
**Figure 50. MPCWT Steel to wood panel point connection failure**

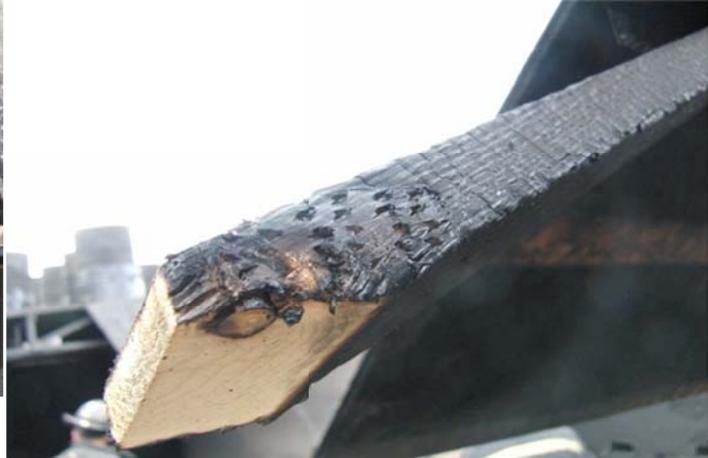
**Figure 51. MPCWT Detail of Connection Failure**

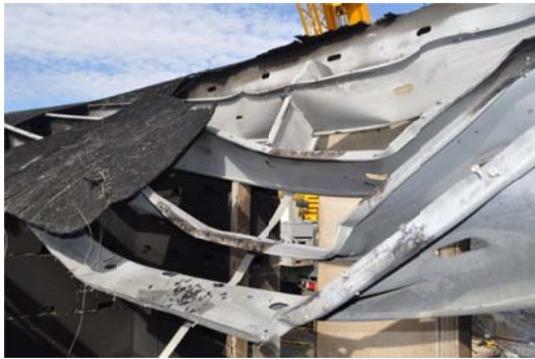
**Figure 52. Steel C-joist Loss of strength inducing progressive joist deformations, sheathing connection failure, joist bracing and lateral bracing strap failure**

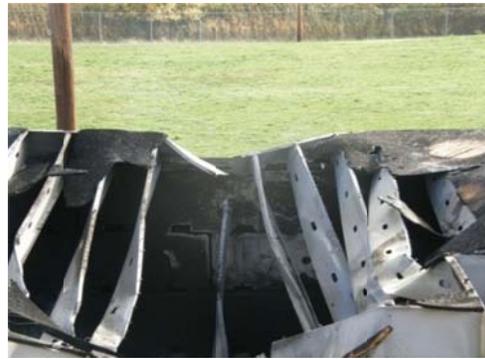
**Figure 53. Steel C-joist deformation detail**

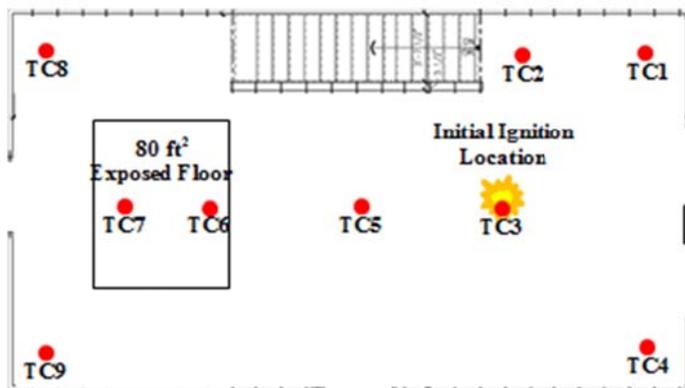
Figure 58. At 13:10 the section of floor above the fire source collapsed. At 15:36 a secondary collapsed occurred that included the center/shorter span next to the stairwell and the span with the unprotected floor area. The three joists that were protected beyond the unprotected area remained intact.
