## **CM Found Not at Fault in Negligence Case**

## **SBCRI Provides Testing Services** to Disprove Product Defect Claims

by Kirk Grundahl, P.E. & Libby Maurer

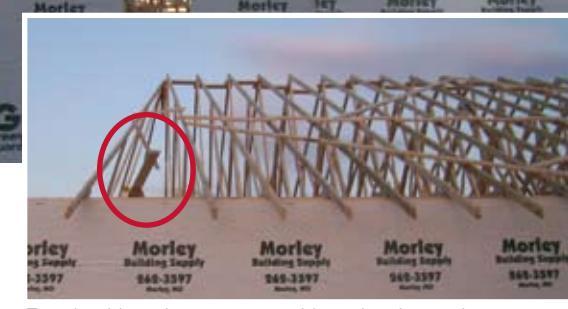
Top chord lateral restraint is visible in the photos above.

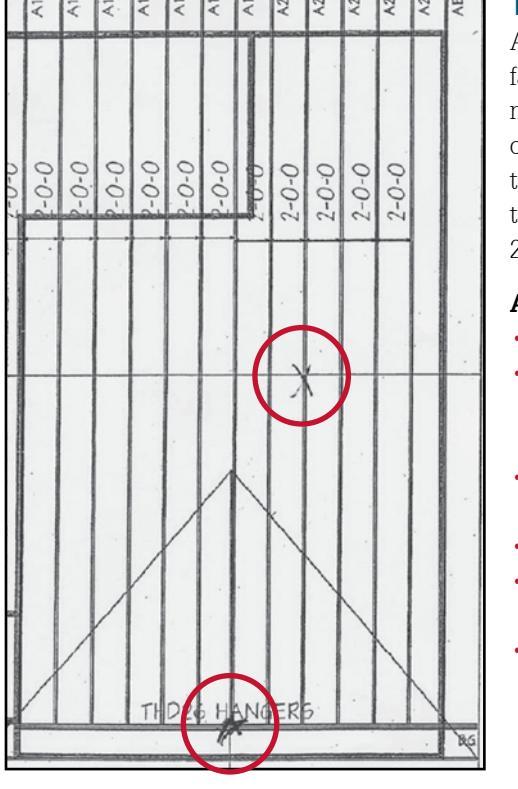
Worker 1 was positioned at the ridge of the truss (top circle in red). Worker 2 (lower circle in red) was installing carried trusses with 3-16d nails through the single ply girder bottom chord. (It was intended to be a 2-ply girder, and the second ply was going to be added later.) When truss A2 fell straight down to the ground, Worker 1 fell with it and died.

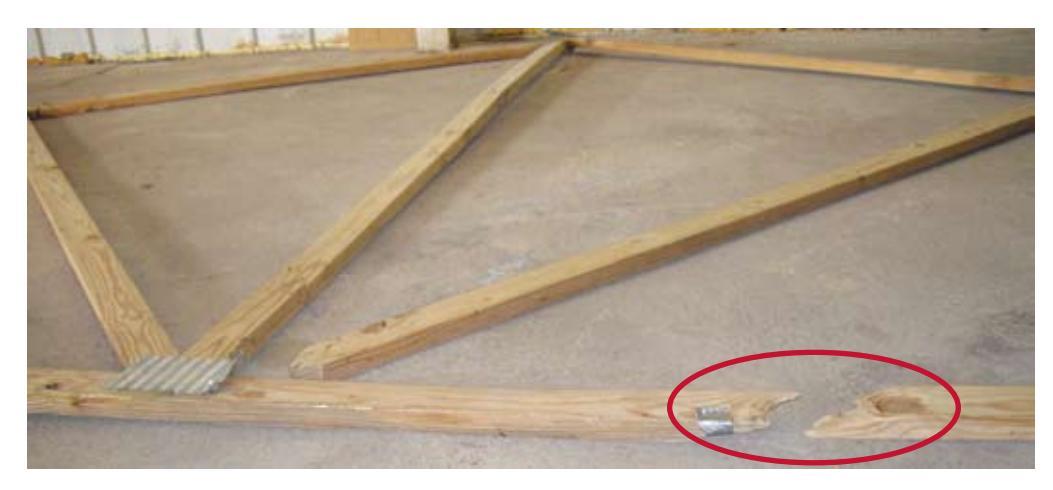
Below: Truss A2 cracked in the bottom chord. The Plaintiff's expert alleged a knot in the same location broke and caused the collapse.

The Plaintiff also sued Heartland for product defect, claiming that the roof truss was "defective and [in an] unreasonably dangerous condition in that it did not have adequate strength for its reasonable foreseeable use due to the excessive amount and size of knots in the wood." They alleged that the truss failed because the knots along the bottom chord (see photo below) weakened the truss, broke and caused the truss to fall to the ground.

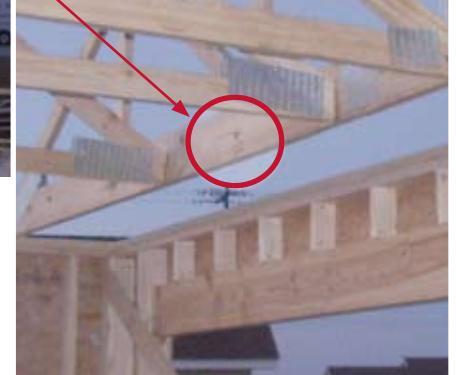
Jobsite photo shows spot where truss pulled away from nails and fell away from the girder truss. SBCRI's challenge was to construct a set-up that precisely replicated the jobsite conditions and what was the likely occurrence and result

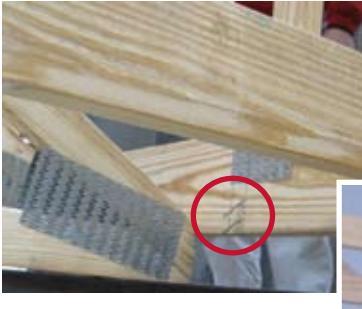
jobsite-the wood at the heel of the truss had split due to nail edge distance, and then pulled away from the 3-16d girder nails. The truss failed just like it failed in the field. The test showed that the failure occurred because of the missing hanger that should have been used to attach A2 to the girder.

A2 fails when the truss pulls out from the two end nails girder during Test 1. No hanger is present. Compare to jobsite failure in photo below.

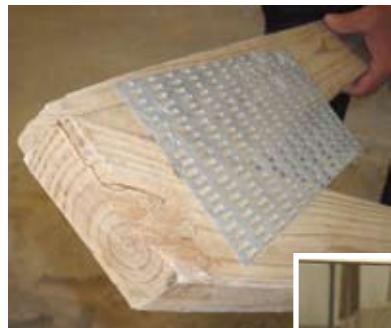
Damage to the actual truss on the jobsite. It shows splitting at the end of the bottom chord.

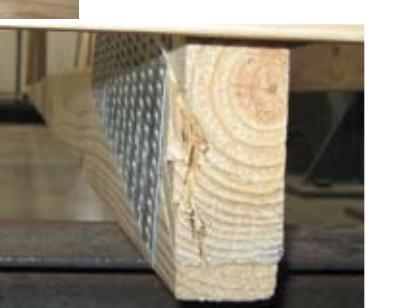
The end of truss A2 used in SBCRI shows splitting.

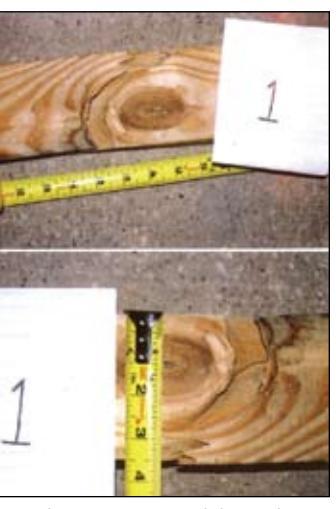
The expert testified that "a combination of the knot and the cross-grain in and around the knot contributed to the cause of truss failure." He said that had the bottom chord been constructed from a piece of wood without crossgrain and without strength reducing characteristics, the truss would not have failed. He also believed the bottom chord failed first and then initated the Photos of expert witness exhibits submitfull failure.

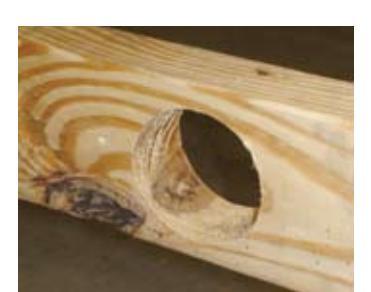
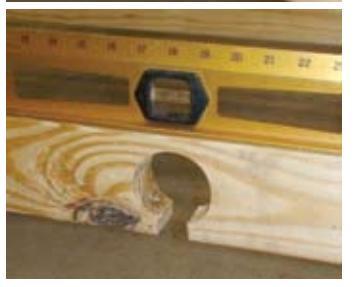
Then to simulate the broken knot area. a hole was cut in the bottom chord of A2. The same five men climbed onto the truss No failure

Then a cut was made through the bottom chord of the first "knot" and loaded with five men No failure
