# Improving Fire Safety by Understanding the Fire Performance of Engineered Floor Systems and Providing the Fire Service with Information for Tactical Decision Making

March 2012

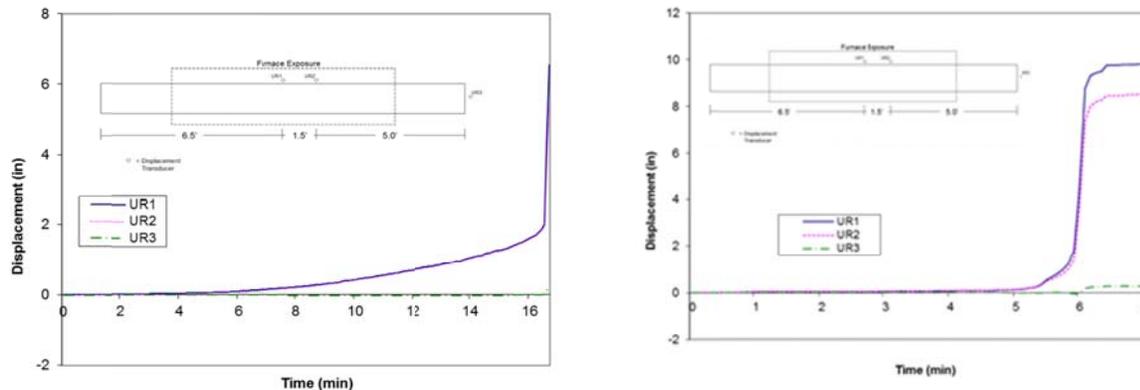
**Figure 9. Deflections for traditional lumber beam (left) and engineered wood I-joist (right)**

The beam only tests confirm the significant performance difference observed for full flooring systems. Traditional lumber beam with rectangular cross section did outperform the engineered wood I-joist in these fire tests. These results show the potential for assessing the fire performance of new wood-based constructions using simple single beam fire tests.

In addition, the availability of video of the burning process for the beams provided insight into the failure path. For the engineered wood I-joists, the failure sequence involves the burnout of the thin web, thereby creating a sudden drop in stiffness as the lower chord, though mostly un-burnt is no longer available for loading sharing.

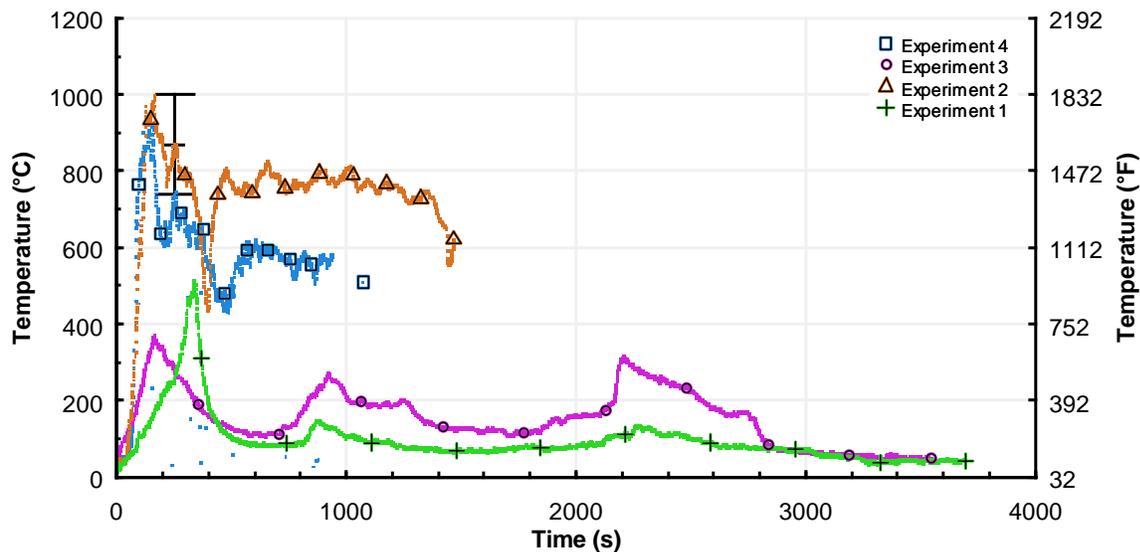
**Figure 21. Temperature at 30 cm from ceiling at the side B location for each experiment.**

The temperature at 30 cm (12 in.) below the ceiling near the initial fuel package is presented in Figure 21 for each experiment. Within the first 100 s (1 min. 40 s), the temperatures from Experiment 2 and Experiment 4 (vents open) reached and sustained temperatures in excess of 500 °C (932 °F) while the temperatures from Experiment 1 and Experiment 3 (vents closed) stayed below 300 °C (572 °F).

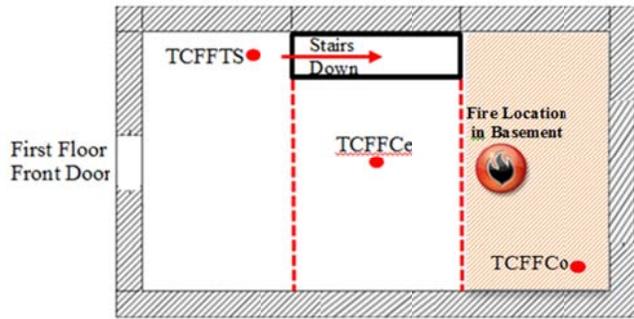
Figure 42. First floor temperature locations and collapse zone

Temperature may not be an important factor in determining the safety of the firefighters operating on the floor above a basement fire. The layout of the first floor indicating the temperature measurement locations as well as the section of the floor that collapsed first in every experiment (shaded in orange) is shown in Figure 42. Firefighters operating near the top of the stairs would feel the highest temperatures and elevated temperatures would be felt on the remainder of the first floor at the 3 ft. elevation (Figure 43 through Figure 45). Most experiments remained tenable for firefighters operating on the first floor as long as it was for a short period of time. Temperatures above 250 °C (500 °F) would not be bearable for a period of time much beyond a couple minutes. There did not appear to be a repeated temperature spike in the corner location, above the collapse area prior to the time of collapse that could be used as a predictor.

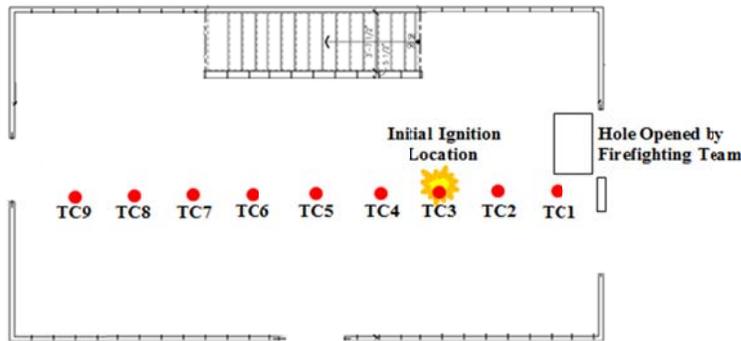
Figure 54. Experiment C Void Thermocouple and Hole Location

In Full-span Laboratory Experiment C a fire was ignited in the void space of the floor system with a ½ in gypsum board ceiling. This fire grew but became ventilation limited and began to smother itself. The fire was not able to self-sustain. In order to examine the fire damage a pike pole was used to open up the floor where the fire was ignited. An approximate 2 ft. by 3 ft. hole was opened just inside the basement doorway (Figure 54). The resulting fire grew differently with the available oxygen, eventually leading to collapse. Figure 55 shows the temperatures in the area of the hole opened up by the firefighters increased and sustained up until the time of collapse. Due to the impact in the fire behavior after the hole was opened, a hoseline should be in place before making an opening to a basement floor void space to limit the impact of adding ventilation to the ventilation limited space.

The temperatures in the basement never exceeded 60 °C (140 °F) for the entire experiment leading up to collapse even though the temperatures in the void space exceeded 700 °C (1300 °F). The fire did burn up through the OSB floor decking well into the experiment. This could ignite a fire on the first floor which could mask the fact that the fire is in the floor system. The crew checking the basement could experience cool temperatures in the basement but should still inspect the floor system by making an opening, with a hoseline available to extinguish any fire they encounter.

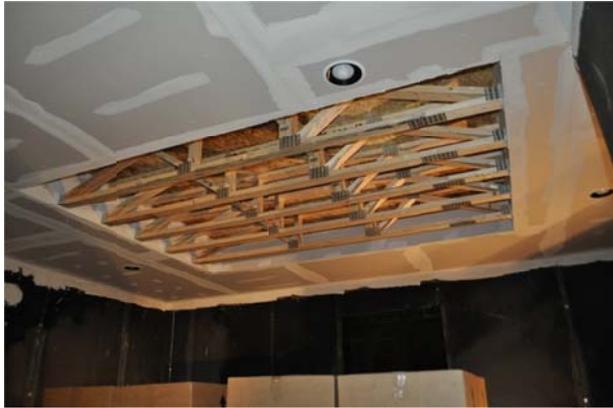
The exception in Section 3.1 of the code allows for an aggregate area of 80 ft<sup>2</sup> of unprotected floor per story. Experiment D was conducted in the laboratory to examine the potential impact of this exposed floor area. This experiment had a 9 ft. 10 in. wide by 7 ft. 9 in. deep exposed truss area that was fire blocked with ½ in. gypsum wallboard on all of the sides (Figure 56 and Figure 57). The exposed area was located on the centerline of the room toward the back of the stairwell location. The fire was ignited at the end of the basement near the doorway as shown in

Figure 56. Close view of exposed trusses

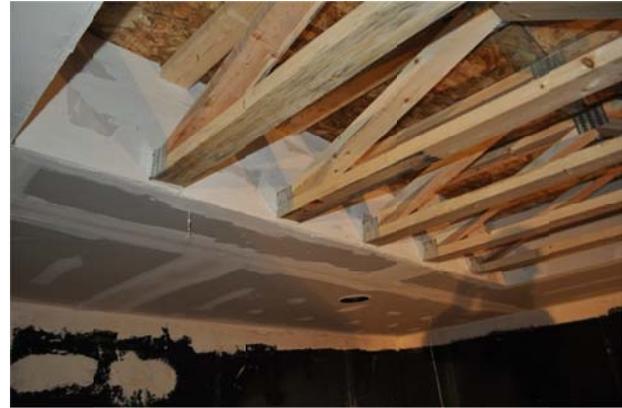
Limiting the fuel load in relation to the exposed floor area or placing the exposed floor area in a separate room from the finished section of the basement would increase the safety when the floor area must be exposed. The fire blocking was also successful in limiting the exposure to the remained of the floor.

Figure 57. Detailed image showing draft stopping of the exposed trusses

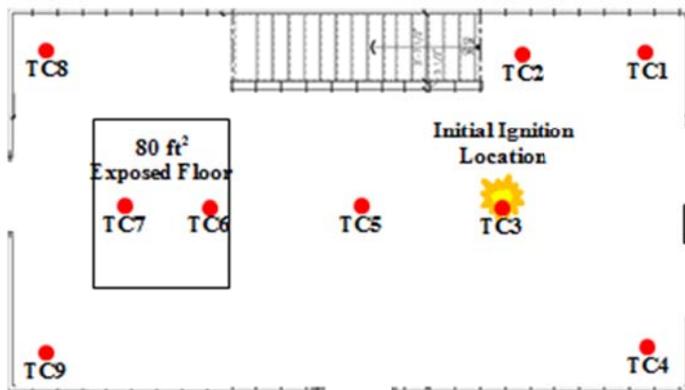
Figure 58. Experiment D Void Thermocouple and Exposed Floor Location

Figure 58. At 13:10 the section of floor above the fire source collapsed. At 15:36 a secondary collapsed occurred that included the center/shorter span next to the stairwell and the span with the unprotected floor area. The three joists that were protected beyond the unprotected area remained intact.

The results of this experiment demonstrate that having an exposed section of flooring remote from the source of the fire doesn't mean that the floor will collapse in that area first. In this case the unprotected area collapsed 2:26 after the protected area over the fire collapsed. Adding gypsum board to a majority of the floor system increased the collapse time of the MPCWT from 3:28 in Experiment 10 to 13:10 in Experiment D. The worst case scenario would be to place the exposed floor area over the fire location however it can be expected that the results would be similar to those of Experiment 10 because the center span of the truss deteriorating over the fire would cause truss failure as the wood was burned away.
