## **CM Found Not at Fault in Negligence Case**

## **SBCRI Provides Testing Services** to Disprove Product Defect Claims

by Kirk Grundahl, P.E. & Libby Maurer

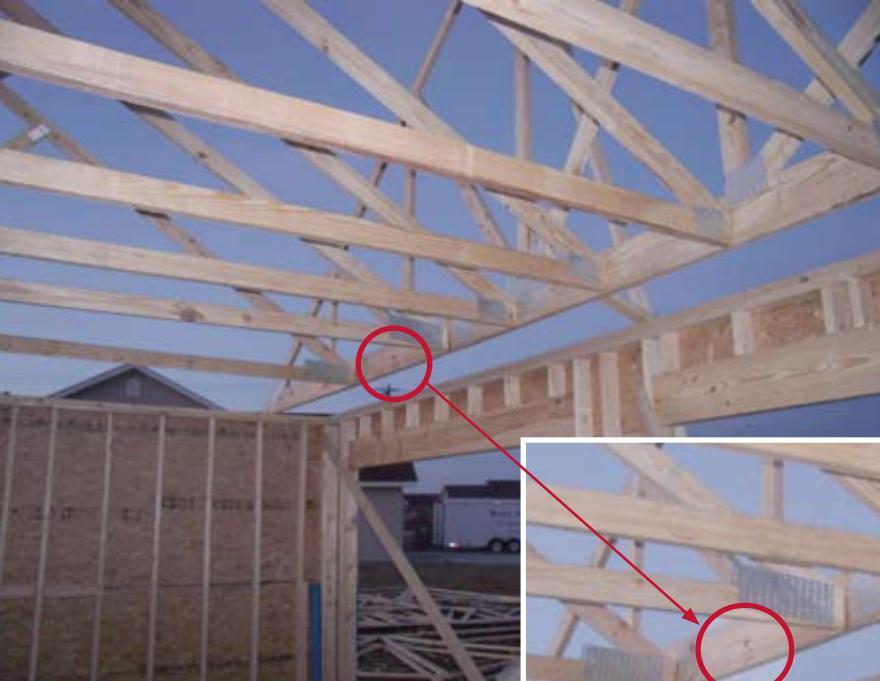
Jobsite photo shows spot where truss pulled away from nails and fell away from the girder truss. SBCRI's challenge was to construct a set-up that precisely replicated the jobsite conditions and what was the likely occurrence and result

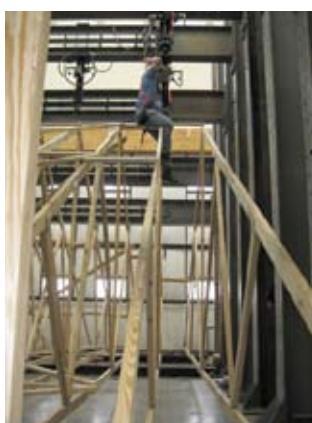
During the test, the truss fell straight down from the girder SBCRI lab staff members were used truss. It was then clear exactly to simulate loads on A2. what had happened on the

jobsite-the wood at the heel of the truss had split due to nail edge distance, and then pulled away from the 3-16d girder nails. The truss failed just like it failed in the field. The test showed that the failure occurred because of the missing hanger that should have been used to attach A2 to the girder.

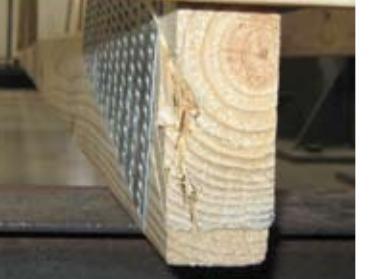
Damage to the actual truss on the jobsite. It shows splitting at the end of the bottom chord.

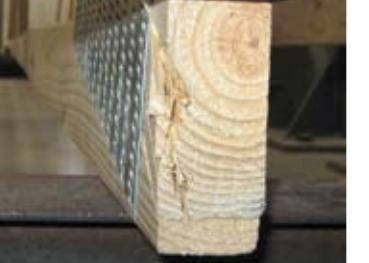
The end of truss A2 used in SBCRI shows splitting.

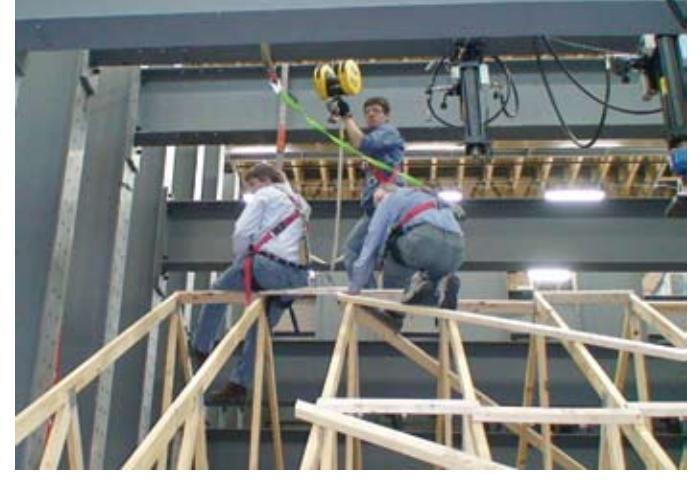
Next, three men were positioned at the top of the truss (as shown in photo above), representing three times the load at the peak of the truss on the jobsite. Two additional men stood on each bearing end of the truss. This is where they stood on the jobsite when installing temporary bracing. With the load of five men on the truss, it did not fail.
