by Agron Gjinolli, P.E. & Larry Wainright

Why proper installation is critical to avoiding this condition.

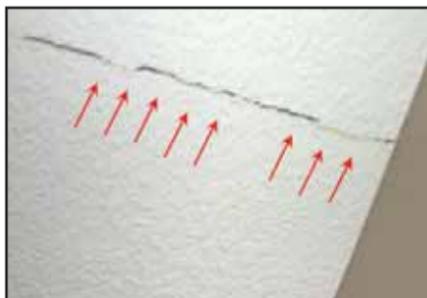
One question that we periodically receive from builders and truss manufacturers pertains to potential causes of cracks in the drywall ceiling that run perpendicular to metal plate connected wood floor or roof trusses. These cracks are typically characterized by their appearance in the center of taped joints running parallel to the drywall panel tapered edges and/or factory seams (see photo). These cracks are primarily observed at the seams of drywall ceiling boards installed in large areas. The cracks may actually tear the drywall tape and may continue to grow over time. Furthermore, the width of the crack may vary cyclically as the seasons change.

Drywall "ridging" is the opposite phenomena to cracking and is characterized by the appearance of a small hump approximately 1/8" to about 3/8" wide, usually running along the taped joint of ceilings with longer spans. Ridging is caused by compression of the edges or ends of the finished and decorated gypsum board. This compression happens when the edges and/or ends expand during alternating periods of high and low humidity and temperature extremes.
