Technical Q&A

Chunk-Out Design Errors

by Rachel Smith

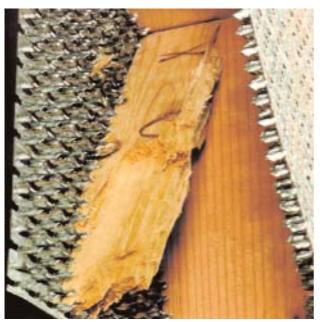
Photo of test joint after chunk-out failure in web.

The chunk-out provision in design software is meant to address a potential design failure where high tension members can tear out the wood at the edge of the teeth along the grain of the wood. You can think about this as very similar to what happens when you split a piece of wood with an ax and it separates along the grain. (See photo.) Generally, changing lumber species or grade won't help; it's based on the size of the member underneath the truss plate and the amount of axial force.

The 1600 lb/in limit specified in Section 8.9.2 was added to the 2002 edition of the Standard to check against a wood "chunkout" failure at tension joints, which testing has shown to be a failure mode that can occur, particularly with narrow-face plating. Test data from applications with plates on the narrow faces of 2x4 lumber has shown that the relatively high stress concentrations in the outermost portion of the narrow lumber faces where the teeth penetrate can result in premature wood fracture when a knot or other grain deviation occurs near the plate. Based on this empirical limit, the maximum normal duration tension load is 2400 lb for a 4x2 or 3x2, and 4800 lb for two 4x2s or two 3x2s.
