Proponent : Larry Wainright, representing Structural Building Components Association (Iwainright@qualtim.com) requests Approve as Modified by this Public Comment.

2015 International Residential Code

R302.13 Fire protection of floors. Floor assemblies that are not required elsewhere in this code to be fire-resistance rated, shall be provided with a 1/2-inch (12.7 mm) gypsum wallboard membrane, 5/8-inch (16 mm) wood structural panel membrane, or equivalent on the underside of the floor framing member as defined by performance equivalent to 26 minutes using ASTM E119 standard fire endurance testing with a superimposed load simulating a maximum load condition (i.e. 100% design load). Penetrations or openings for ducts, vents, electrical outlets, lighting, devices, luminaires, wires, speakers, drainage, piping and similar openings or penetrations shall be permitted.

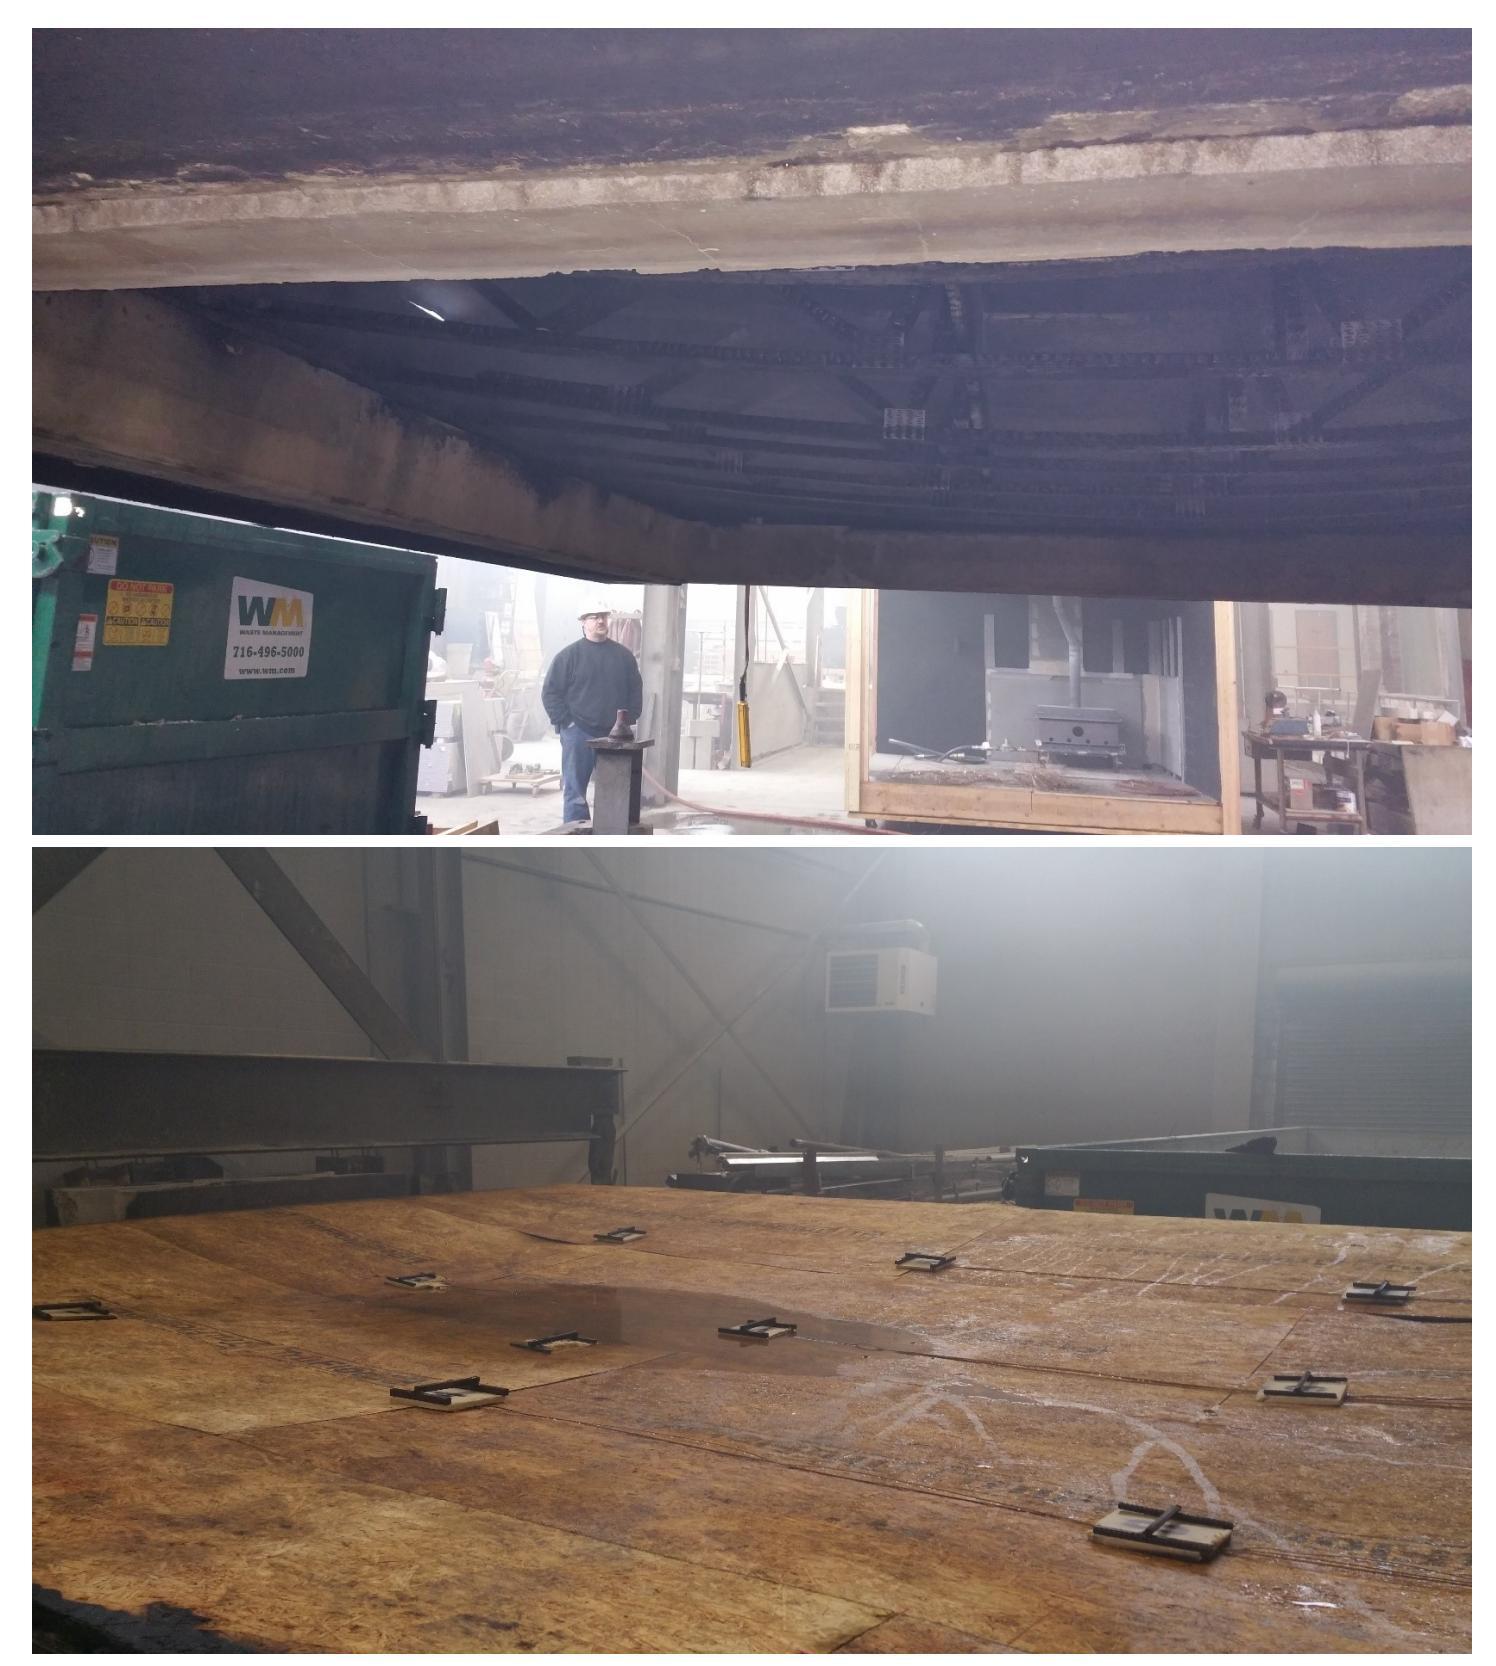
Further, the SBCA testing show ed that 2x10 dimensional lumber failed with a complete collapse of the structure, w hereas the truss tests were stopped at the 6:54 mark due to deflection in the trusses. The truss system did not collapse into the furnace as show n by the follow ing picture post ASTM E119 test:
